Reconstructing Christchurch:
A Seismic Shift in Building Structural Systems
February 13, 2019

Michel Bruneau, Ph.D., P.Eng
Department of Civil, Structural and Environmental Engineering
University at Buffalo

Gregory A. MacRae, Ph.D.
Department of Civil and Natural Resources Engineering
University of Canterbury

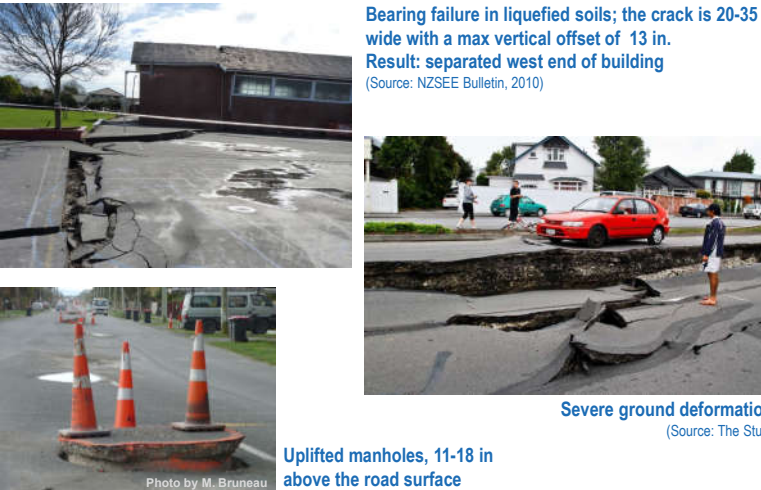
Bearing failure in liquefied soils; the crack is 20-35 in wide with a max vertical offset of 13 in.
Result: separated west end of building
(Source: NZSEE Bulletin, 2010)

Uplifted manholes, 11-18 in above the road surface
Photo by M. Bruneau

Severe ground deformation
(Source: The Stuff)

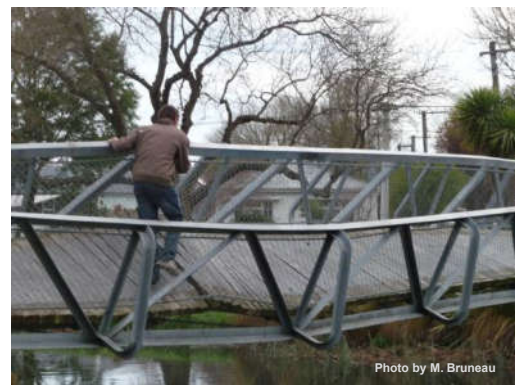
Avonside Drive Pedestrian Bridge

- Bearing connection at abutment had shear type failure in longitudinal direction indicating large longitudinal compressive force in bridge structure
- Large longitudinal force in bridge structure lead to global lateral torsional buckling of entire bridge deck

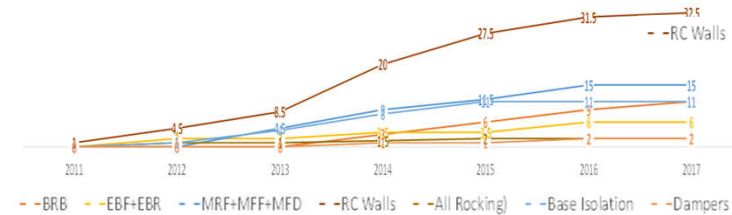
- RC walls = largest number because this category (contrary to others) is not broken down into sub-categories
- Data shows only a few moment frame with friction connections, rocking systems, LVL systems, CBFs, and dampers

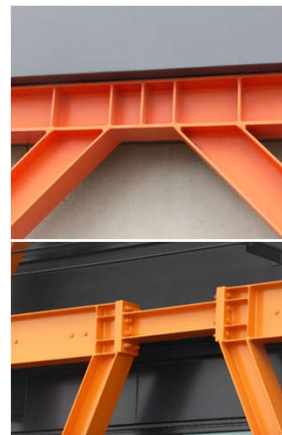
- Split opinions on EBFs with or without replaceable links
 - Some expressed strong preference for bolted replaceable links and decoupling of link and link-beam design
 - Others held that replacing links might not be performed as easily as foreseen
 - Many held that replacing the link in a conventional EBF is not necessarily more difficult: links can be cut and replaced by new segments welded-in-place (as done in a number of post-Christchurch repairs)
- Concerns voiced that some of the replaceable links in new buildings appear out of proportion with the rest of their frame
